APPENDIX A: SOIL/FILL AREA/VOLUME DELINEATION INFORMATION

Remedial Footprint Information

Remedial investigation (RI) soil results and historical data were used to develop the footprints for the soil and soil gas remedial alternatives. Appendix A prepared by USEPA describes the methodology used to prepare these footprints; delineations will be completed during the remedial design. All of the data used for this evaluation are provided in Table 3-5A through Table 3-5D in the Feasibility Study (FS) Report. For each sample listed in the Table 3-5 series, information is provided on the property lot number, location identification (ID), sample date, depth interval in units of feet below ground surface (bgs), sample type (indicating a primary environmental sample or a quality control field duplicate), and information on the associated parent and field duplicate pair. The laboratory results and the associated qualifier are presented. The RI soil data were provided by PPG Industries, Inc. (PPG) and their consultants, Woodard & Curran, on January 17, 2020. The historical data were provided by PPG/Woodard & Curran as Appendix F of the 2015 Site Characterization Summary Report (SCSR).

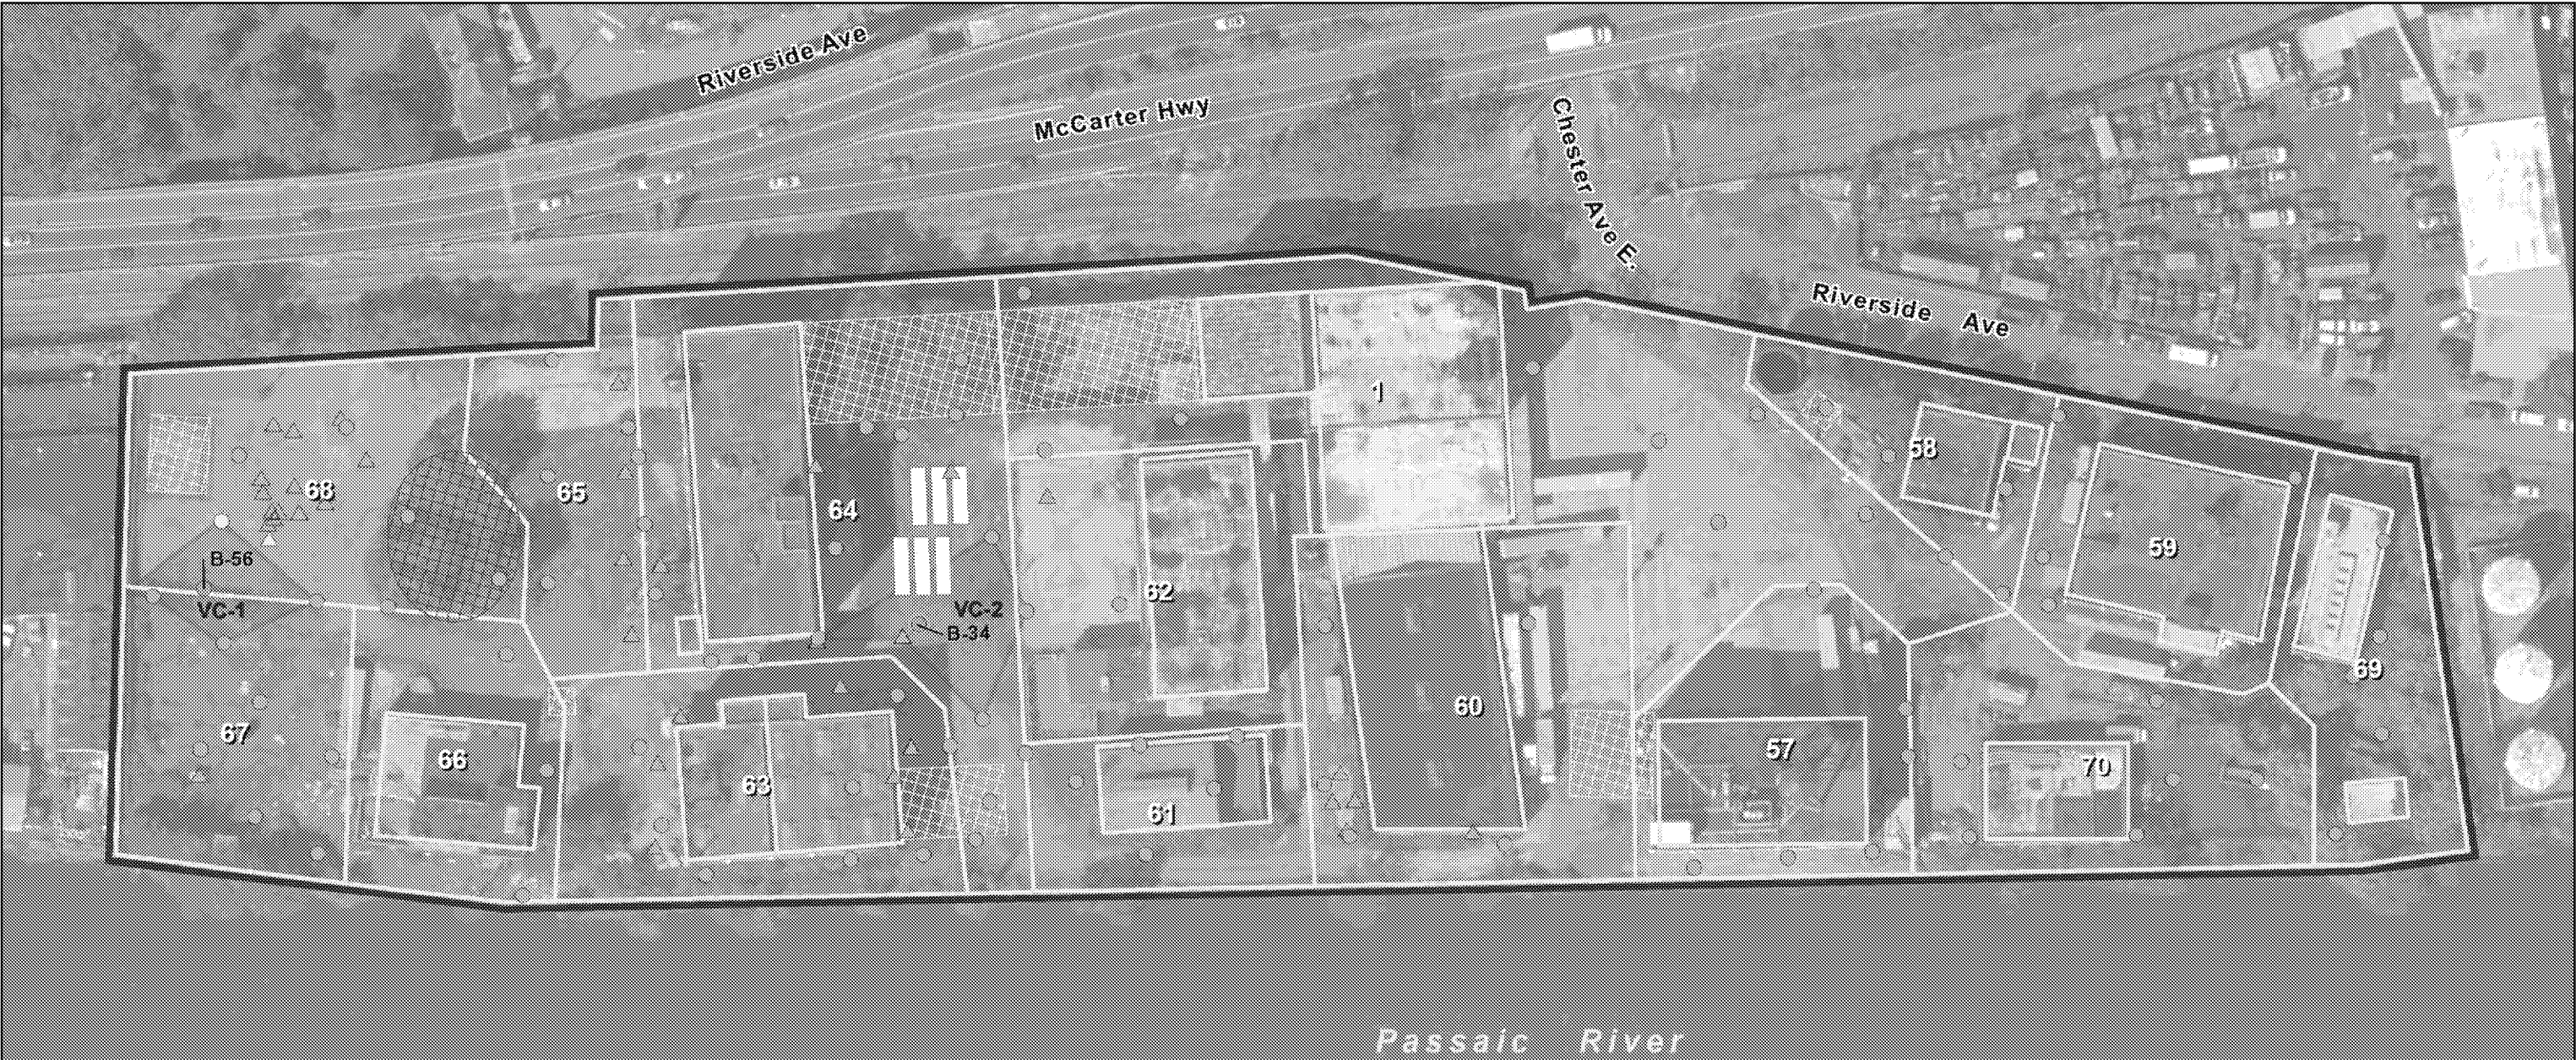
Figure A-11

Area	SqFt	Acres
VC-1	2,935.72	0.07
VC-2	4,084.71	0.09

Site-Wide Sampling Results for

Soil Alternatives: Vinyl Chloride

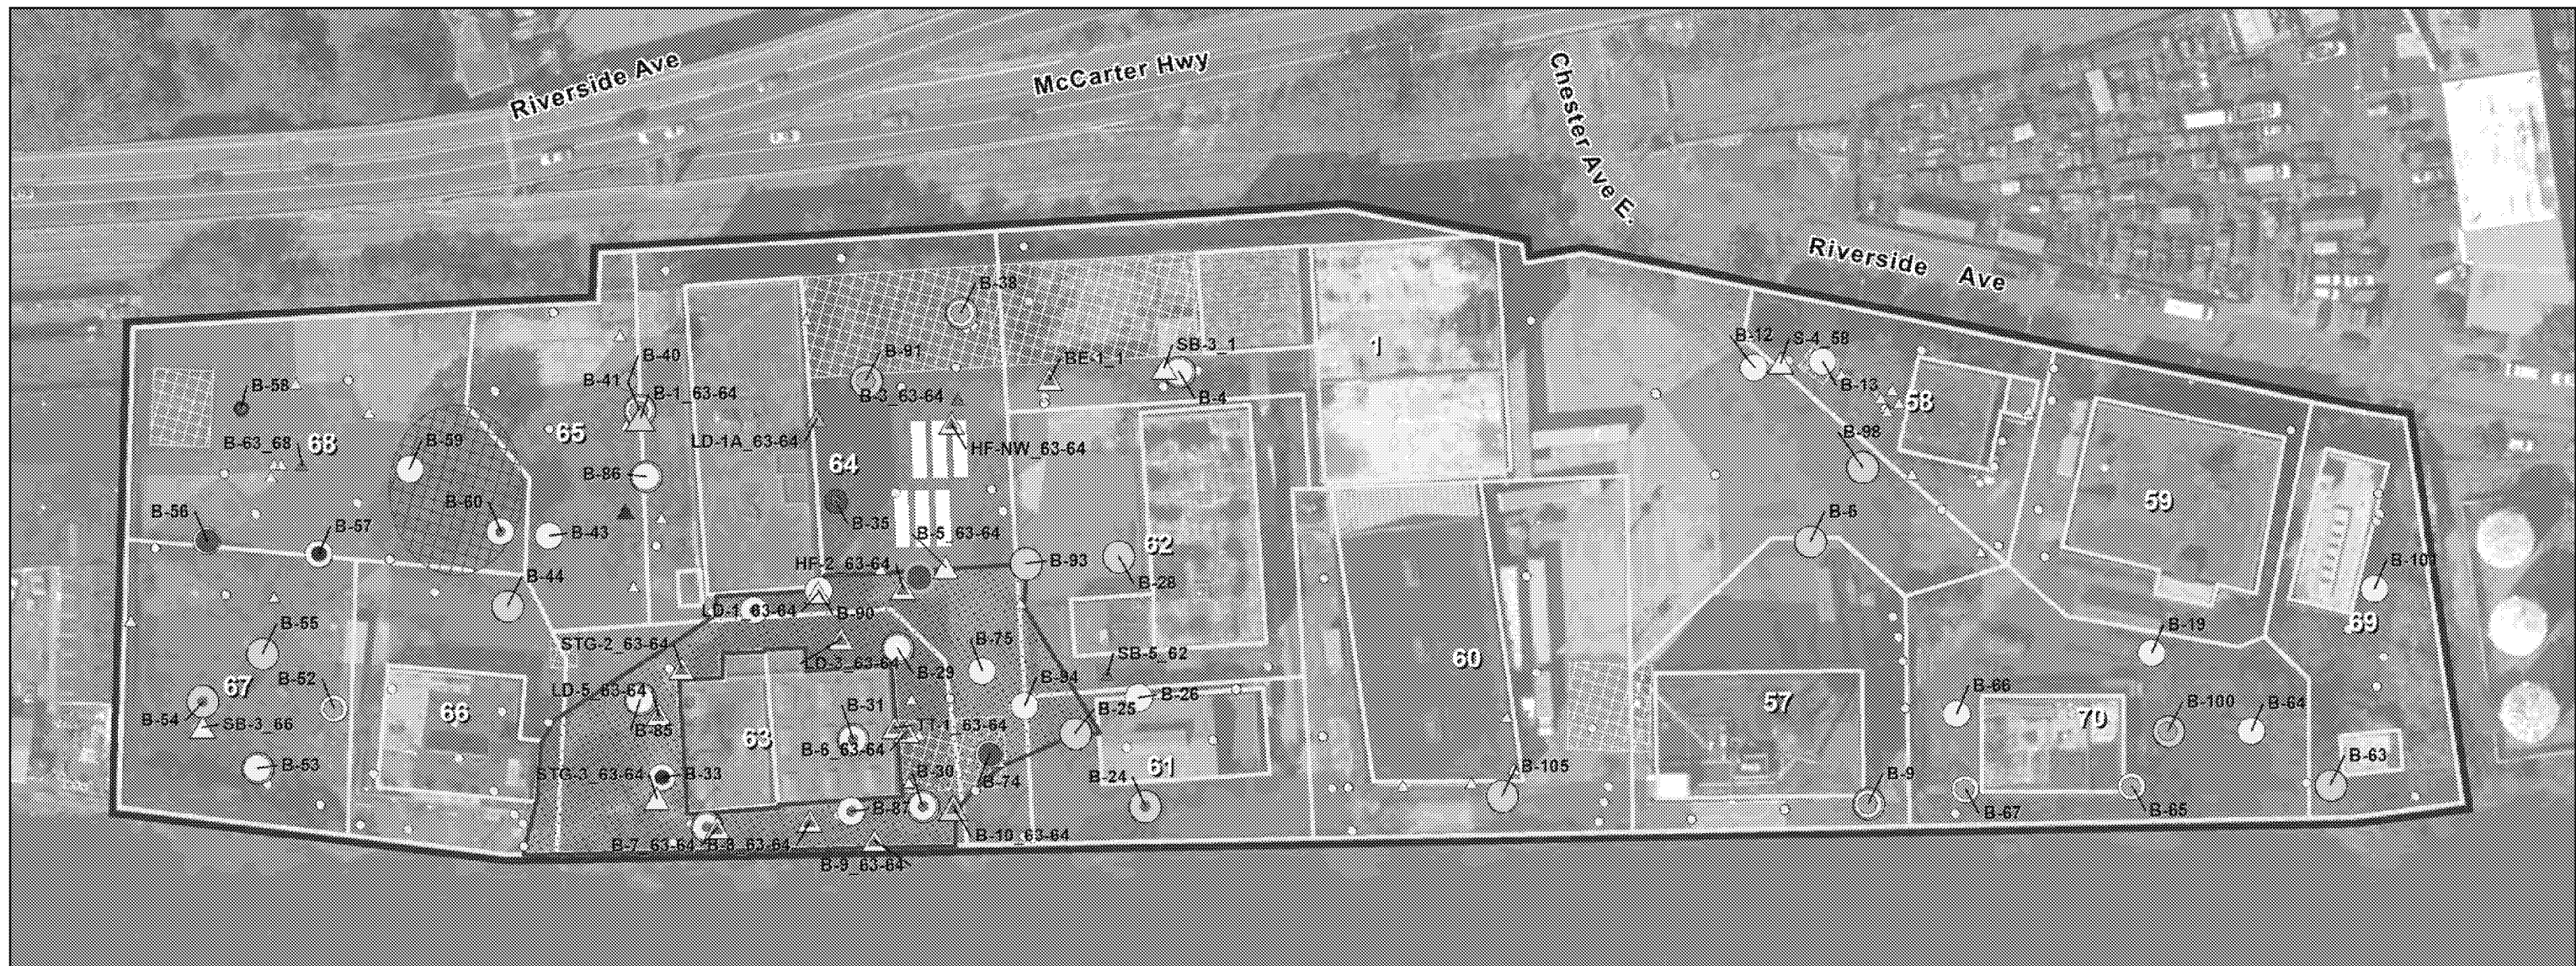
Figure A-12
Site-Wide Sampling Results for
Soil Alternatives: Combined Parameters
Riverside Industrial Park Superfund Site
Essex County, New Jersey

Area of Remedial Action	
SqFt	Acres
157,654.08	3.62
PAHs include: Benzo(a)anthracene, Benzo(a)pyrene, Benzo(b)fluoranthene, Dibenzo(a,h)anthracene	
VOCs include: Benzene, Naphthalene, Vinyl Chloride

- All polygons areas for all the COPCs were assimilated into one composite figure and were summed after removing overlapping polygons to generate a footprint for the remedial action. One footprint was created for the Soil/Fill Alternatives and another was created for the Soil Gas Alternative.

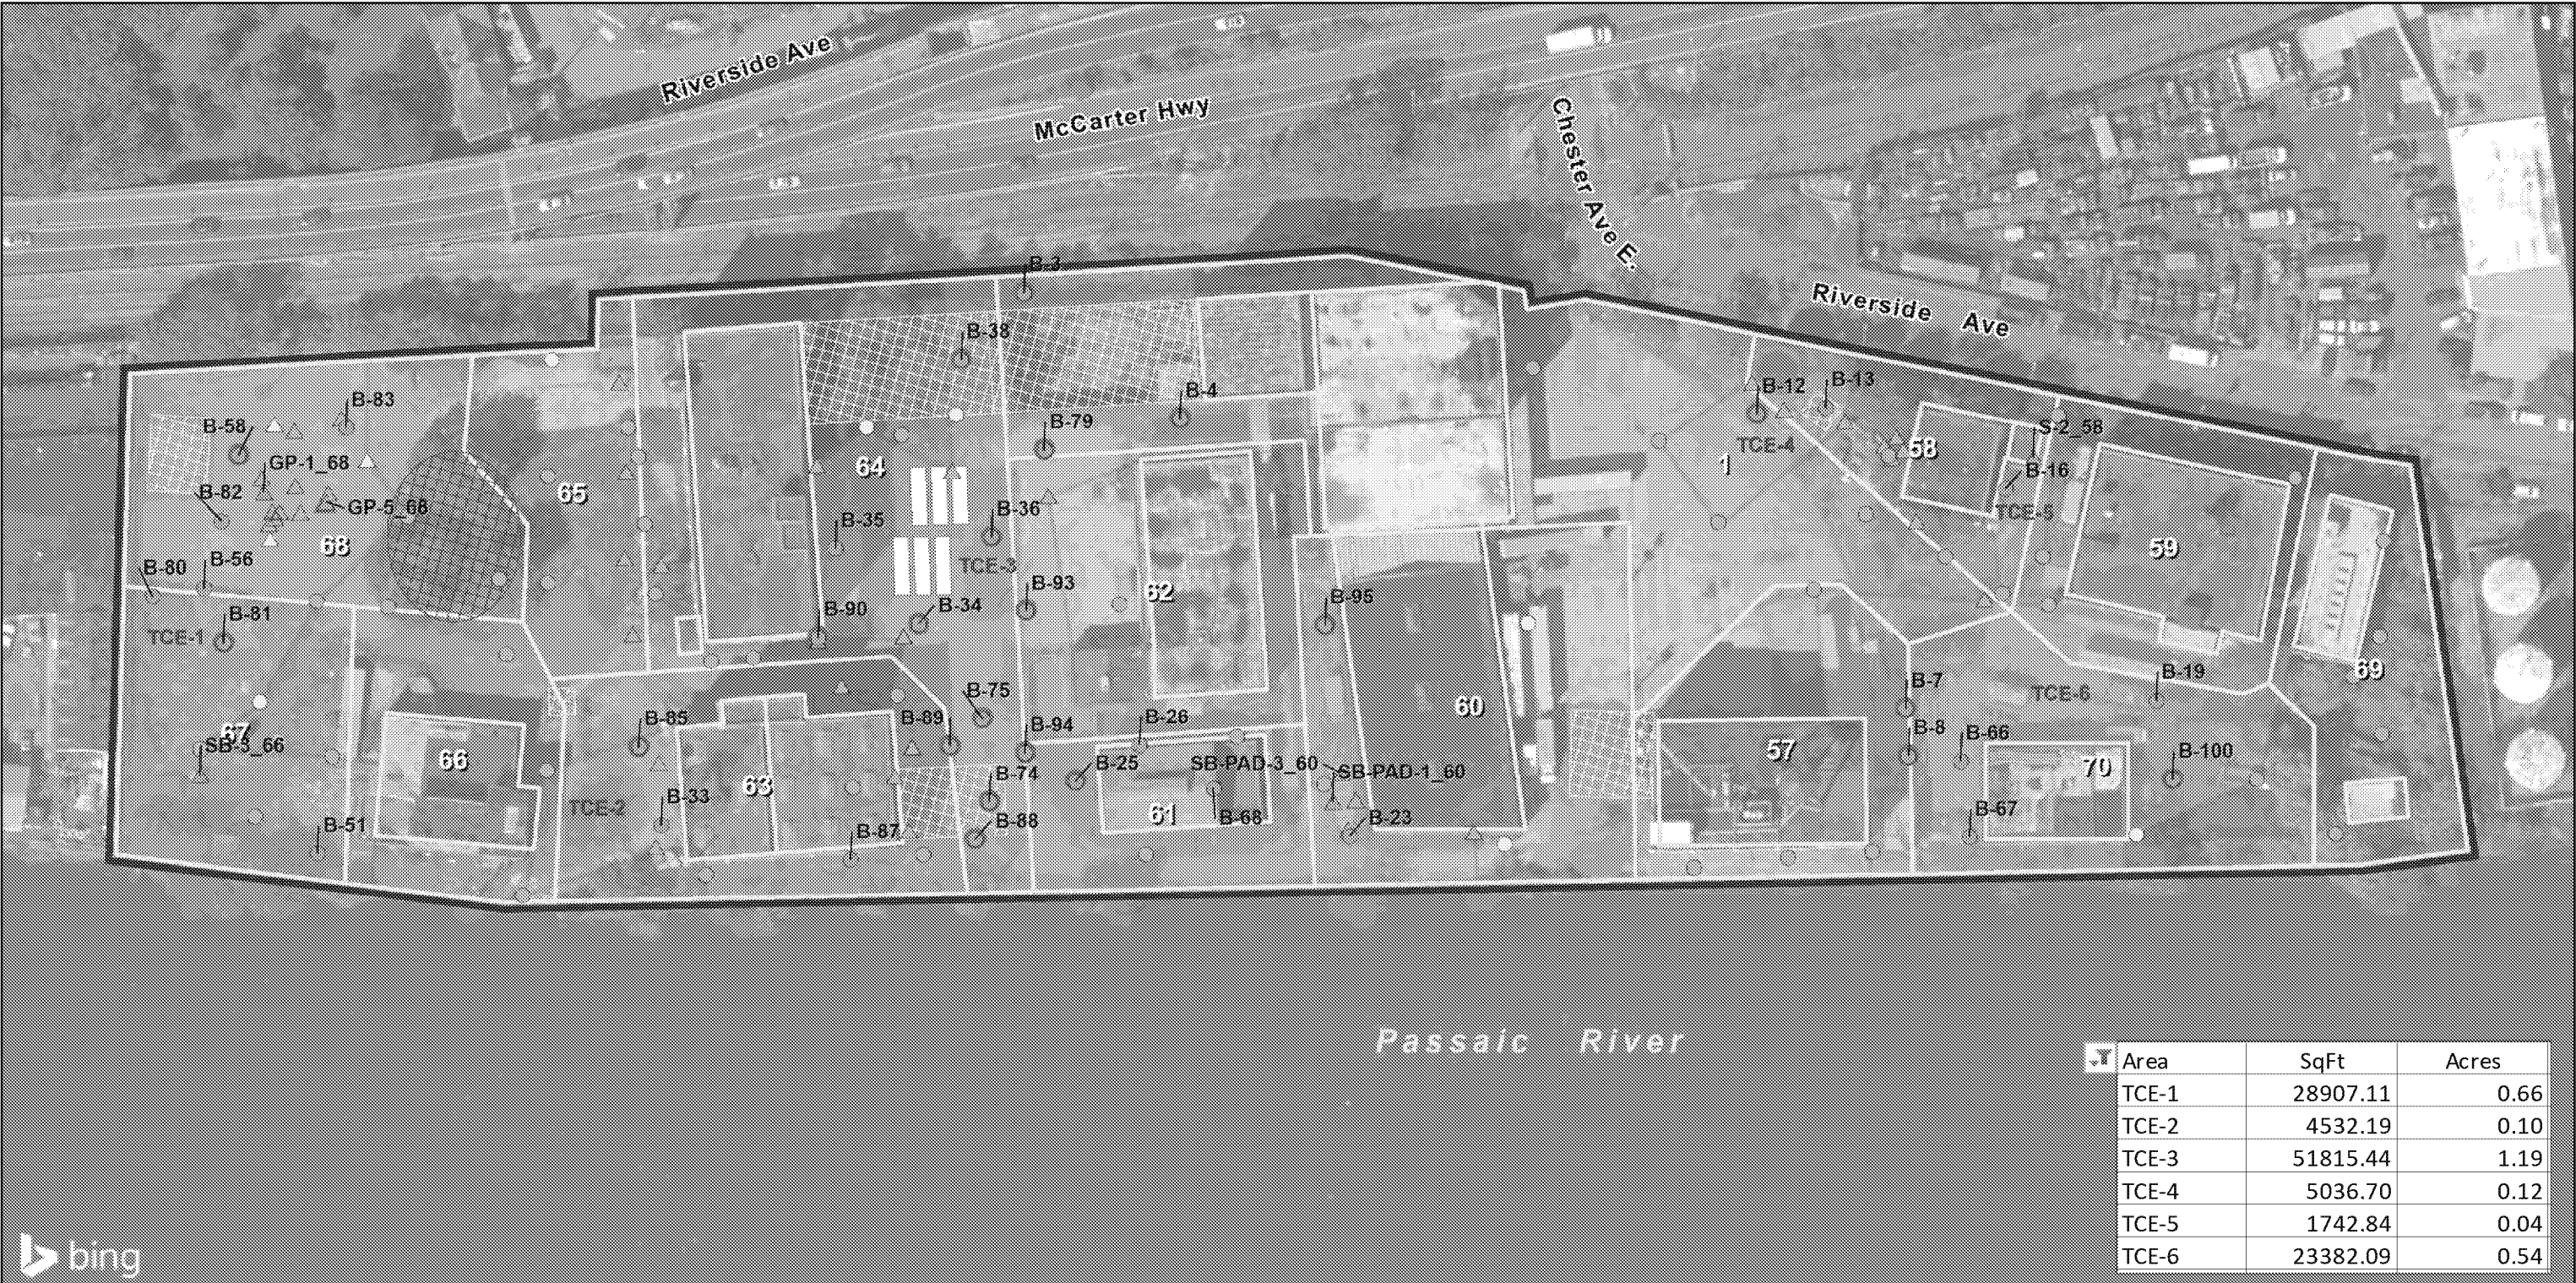
Site-Wide Soil Sampling Results for
Soil Gas Alternative: TCE-PRG
Riverside Industrial Park Superfund Site
Essex County, New Jersey

Figure	COPCs	Area	SqFt	Acres
Figure A-7	Dibenzo(a,h)anthracene	D(a,h)A-1	2,558.98	0.06
		D(a,h)A-2	4,020.10	0.09
Figure A-8	PCBs (Total)	PCB-1	3,661.67	0.08
		PCB-2	3,311.66	0.08
		PCB-3	7,001.54	0.16
		PCB-4	10,318.49	0.24
Figure A-9	Benzene	Benzene-1	5,206.38	0.12
		Benzene-2	5,205.43	0.12
Figure A-10	Naphthalene	NAPH-1	3,203.09	0.07
Figure A-11	Vinyl Chloride	VC-1	2,935.72	0.07
		VC-2	4,084.71	0.09
Figure A-12	Footprint of the Soil/Fill Remedial Alternative (composite figure of all parameters)		157,654.08	3.62
Figure A-13	Naphthalene	NAPH-1	13671.79	0.31
		NAPH-2	2527.79	0.06
		NAPH-3	8077.46	0.19
		NAPH-4	16078.8	0.37
		NAPH-5	11021.63	0.25
		NAPH-6	2077.04	0.05
		NAPH-7	37278.79	0.86
		NAPH-8	3687.5	0.08
Figure A-14	Trichloroethene	TCE-1	28907.11	0.66
		TCE-2	4532.19	0.1
		TCE-3	51815.44	1.19
		TCE-4	5036.7	0.12
		TCE-5	1742.84	0.04
		TCE-6	23382.09	0.54
Figure A-15	Xylenes (Total)	Xy-1	6832.53	0.16
		Xy-2	3749.6	0.09

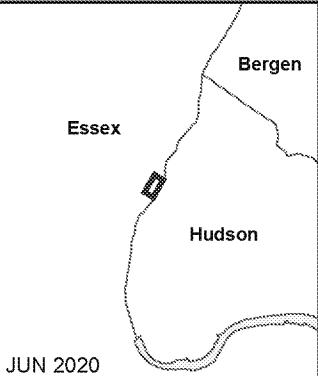
Figure A-15
Site-Wide Soil Gas Sampling Results for
Soil Gas Alternatives: Xylenes (Total)
Riverside Industrial Park Superfund Site
Essex County, New Jersey

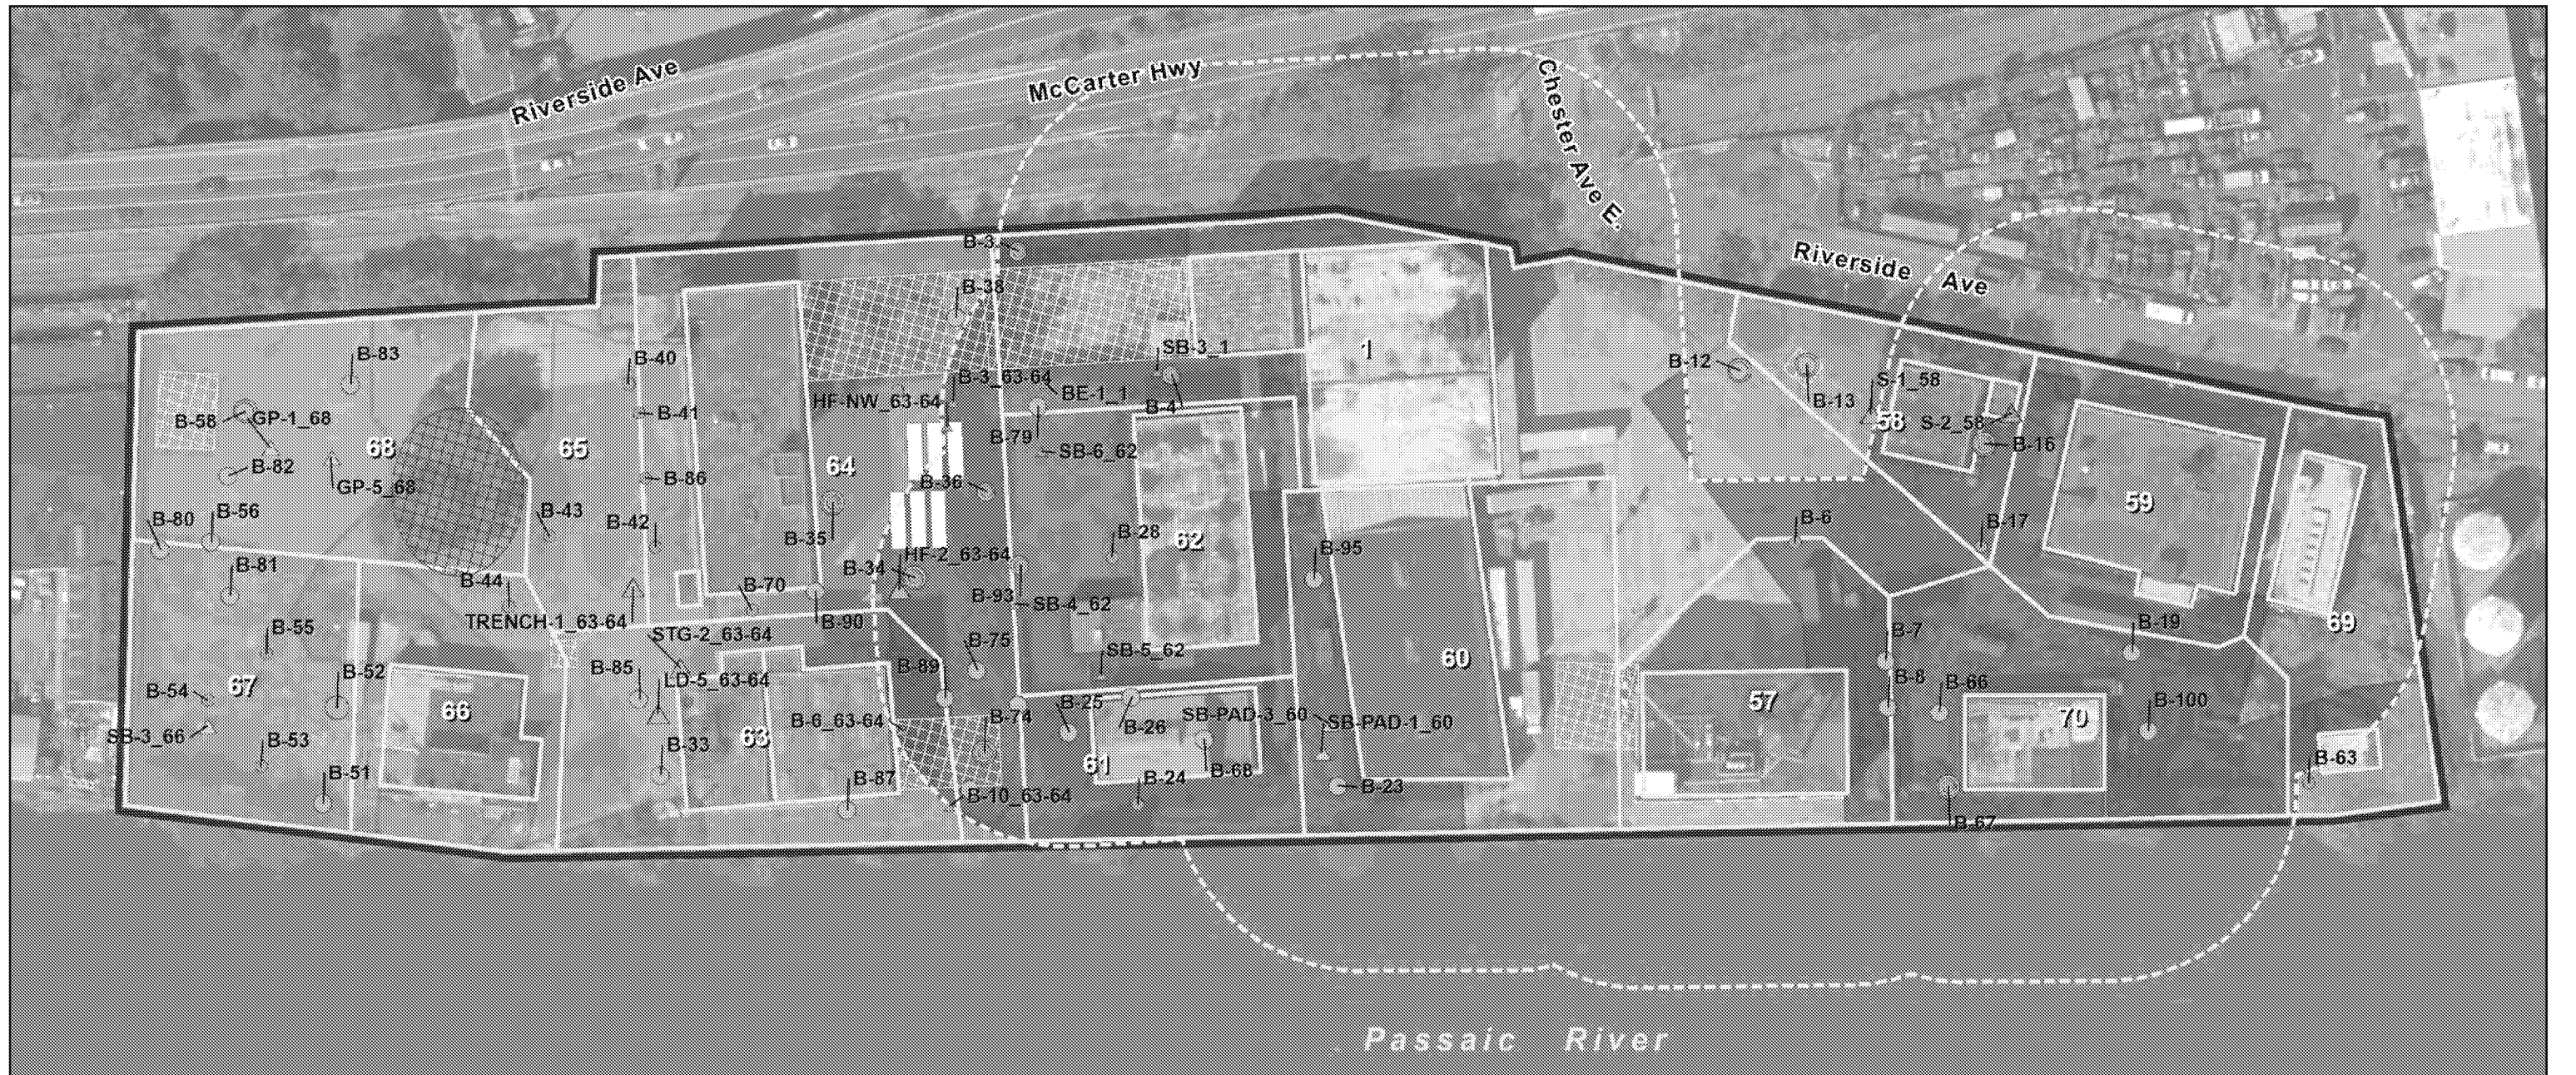
Figure A-16
Site-Wide Sampling Results for
Soil Gas Alternatives: Combined Parameters
Riverside Industrial Park Superfund Site
Essex County, New Jersey

- Study Area
- Parcel (Newark, Oct 2017)
 - 100 Foot Buffer of Existing Occupied Building
 - Footprint of Remedial Action
 - Within 100 feet of Existing Occupied Building
 - Outside of 100-foot Occupied Building Area

Remedial Action Area		
	SqFt	Acres
Total Area Extent	164,179.88	3.77
Portion of Total Area within 100 feet of an Existing Occupied Building	84,868.45	1.95

Xy-3	6933.22	0.16
		Xy-4	9386.19	0.22
		Xy-5	1685.91	0.04
		Xy-6	12740.48	0.29
		Xy-7	3087.33	0.07
Figure A-16	Footprint of the Soil/Fill Remedial Alternative (composite figure of all parameters)		164,179.88	3.77
